**DEPARTMENT OF TRANSPORTATION****DIVISION OF ENGINEERING SERVICES**

Contract #: 04-0120F4Cty: SF/ALA Rte: 80 PM: 13.2/13.9File #: 69.28**WELDING INSPECTION REPORT****Resident Engineer:** Siegenthaler, Peter**Address:** 333 Burma Road**City:** Oakland, CA 94607**Report No:** WIR-022134**Date Inspected:** 23-Mar-2011**Project Name:** SAS Superstructure**OSM Arrival Time:** 700**Prime Contractor:** American Bridge/Fluor Enterprises, a JV**OSM Departure Time:** 1900**Contractor:** Zhenhua Port Machinery Company, Ltd (ZPMC), Changxing Island **Location:** Shanghai, China**CWI Name:** An Qing Xiang**CWI Present:** Yes No**Inspected CWI report:** Yes No N/A**Rod Oven in Use:** Yes No N/A**Electrode to specification:** Yes No N/A**Weld Procedures Followed:** Yes No N/A**Qualified Welders:** Yes No N/A**Verified Joint Fit-up:** Yes No N/A**Approved Drawings:** Yes No N/A**Approved WPS:** Yes No N/A**Delayed / Cancelled:** Yes No N/A**Bridge No:** 34-0006**Component:** OBG**Summary of Items Observed:**

## WELDING INSPECTION REPORT

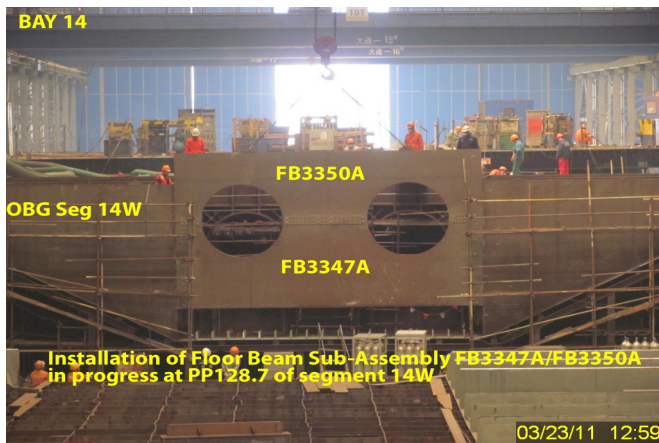
During random in process inspection this QA inspector observed the installation of Floor Beam Sub Assembly FB3450A/FB3347A at Panel Point 128.7 of segment 14W. See attached photographs for more details.

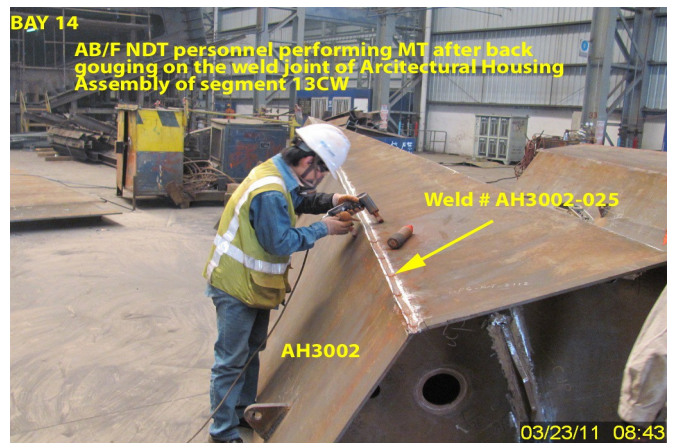
During random in process inspection this QA inspector observed that AB/F NDT personnel Mr. Wang Bei was performing Magnetic Particle Testing (MT) on the back gouging area of weld joint of Architectural Housing (AH) Sub Assembly of segment 13CW. The weld joint is identified as AH3002-025. See attached photographs for more details.

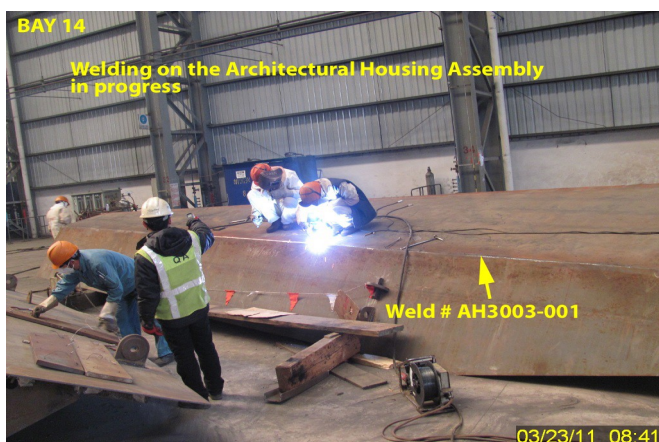
The FCAW process on weld joint no: AH3003-001[EP3026A to SP3115A, CJP weld]. The welders are identified as 066695 and 047866 and were observed welding in 1G position. ZPMC QC was identified as An Qing Xiang. The welding variables recorded by this QC appeared to comply with WPS: B-T-2231-ESAB. See attached photographs for more details.
